ANDERSON LAKE DAM
JEFFERSON COUNTY, MISSOURI
MISSOURI INVENTORY NO. 30410

PHASE I INSPECTION REPORT
NATIONAL DAM SAFETY PROGRAM

Name of Dam: Anderson Lake Dam
State Located: Missouri
County Located: Jefferson County
Stream: No Name
Date of Inspection: 7 September 1978

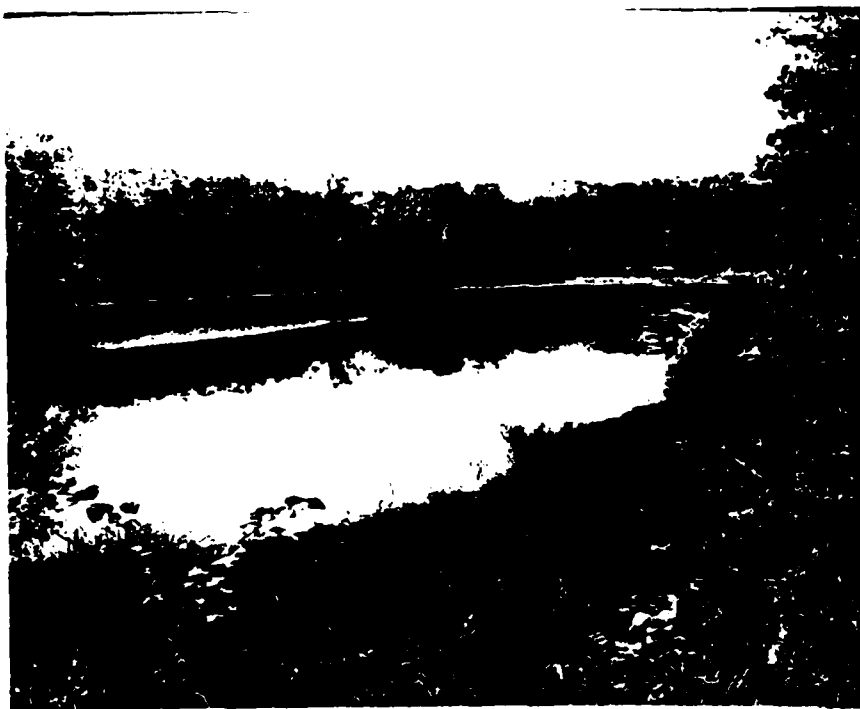
PHOTO 1: UPSTREAM VIEW OF LAKE
